DOSYA NO (FILE NUMBER) : 24-H25 / ITEM 11

MALZEME ADI (MATERIAL NAME) : TRANSDUCER,ULTRASONIC TEST

A1-862QA-MDB-100
IRAC 7 – 19 MAY 2010

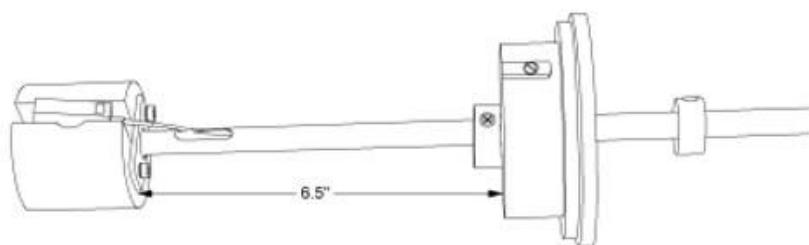
Figure 3-7B – Ultrasonic Inspection Tool I

HB-2344 Ultrasonic Inspection Tool with the lower stop positioned such that the distance between the upper face of the Tool Head and the lower face of the Locating Disk is 6.5-inches.

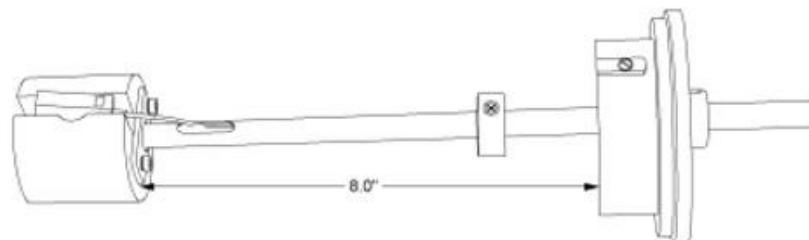
Figure 3-7C – Ultrasonic Inspection Tool II

HB-2344 Ultrasonic Inspection Tool with the upper stop positioned such that the distance between the upper face of the Tool Head and the lower face of the Locating Disk is 8.0-inches.

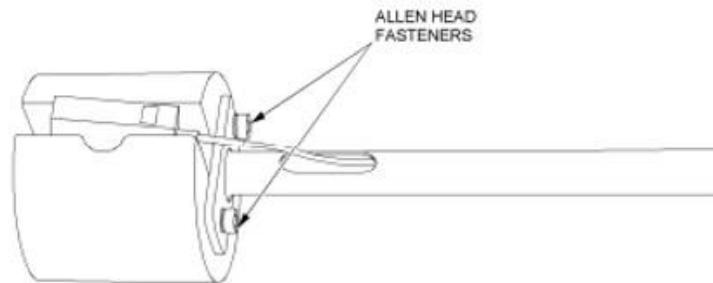
Figure 3-7D – Ultrasonic Inspection Tool Head

HB-2344 Ultrasonic Inspection Tool showing the two fasteners attaching the inspection tool head and the metal flange.

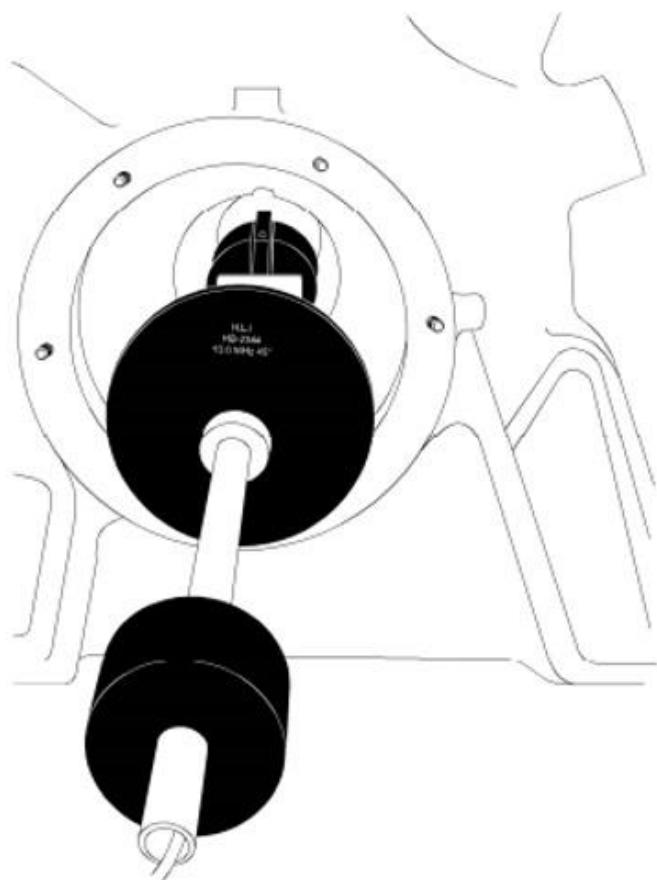
Figure 3-7H – Ultrasonic Inspection Tool in Output Bevel Gear Bore
